## FIRST FIVE YEAR REVIEW REPORT

### KENNECOTT SOUTH ZONE

OU 1 Bingham Creek  
OU 4 Large Bingham Reservoir  
OU 5 Copperton Tailings  
OU 10 Copperton Soils  
OU 11 Bingham Canyon  
OU17 Bastian Sink

June, 2004

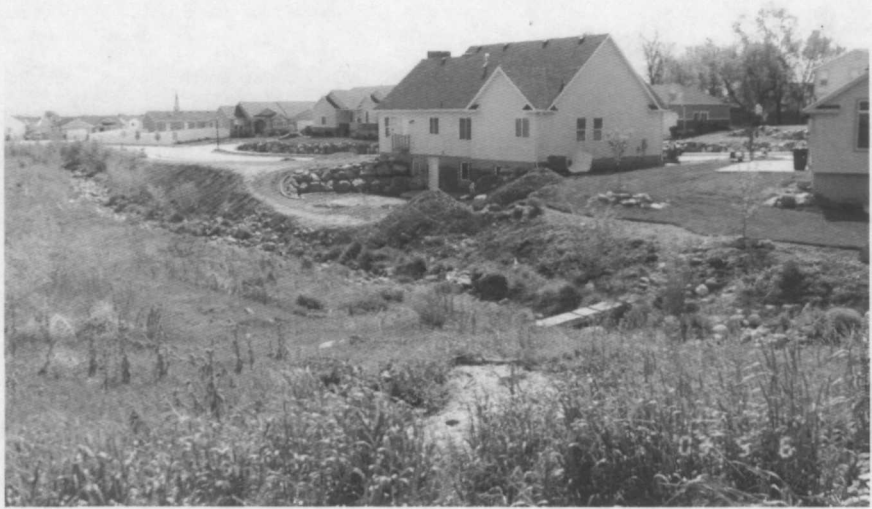
**Figure 1:** The Woods at Creekview. New construction and landscaping comes right up to the creek channel

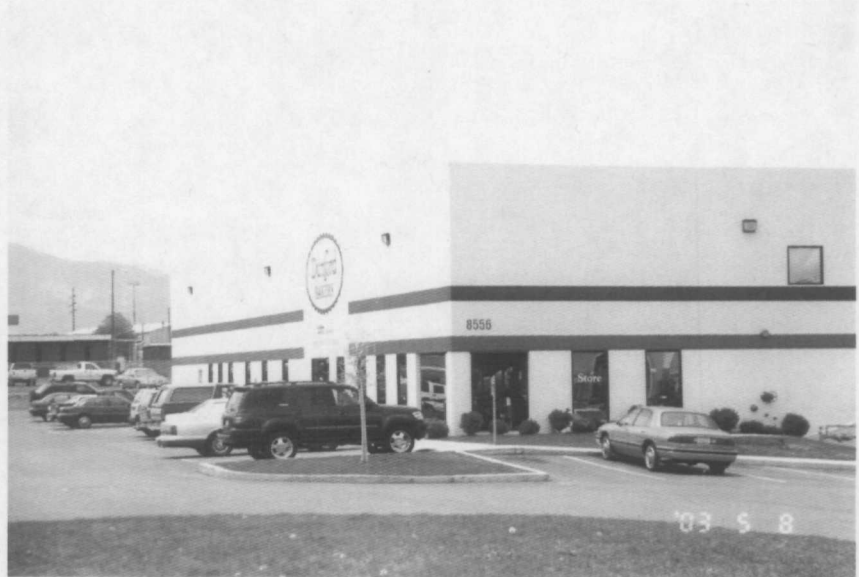
**Figure 2:** Mountain View Business Park, pad construction on top of the remedy

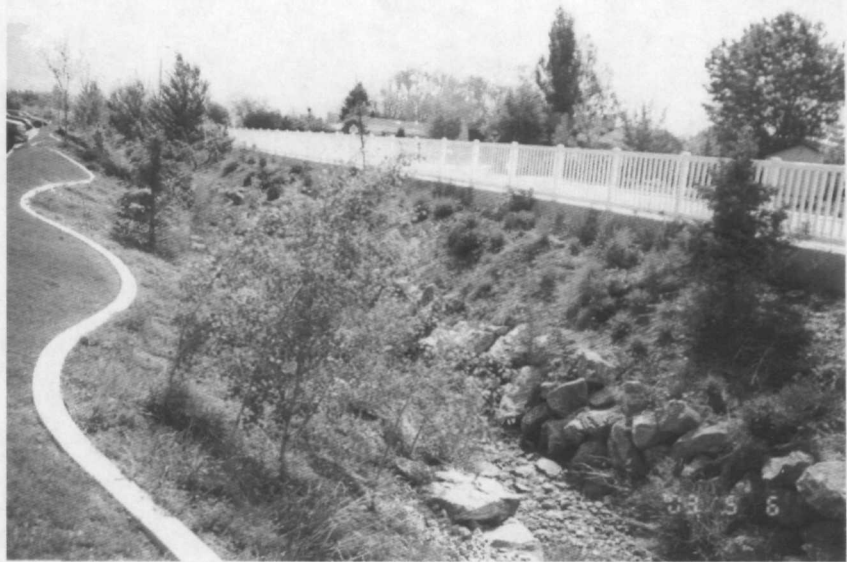
**Figure 3:** Newly reconstructed Bingham Creek Channel in front of the Cascade Springs Apartments

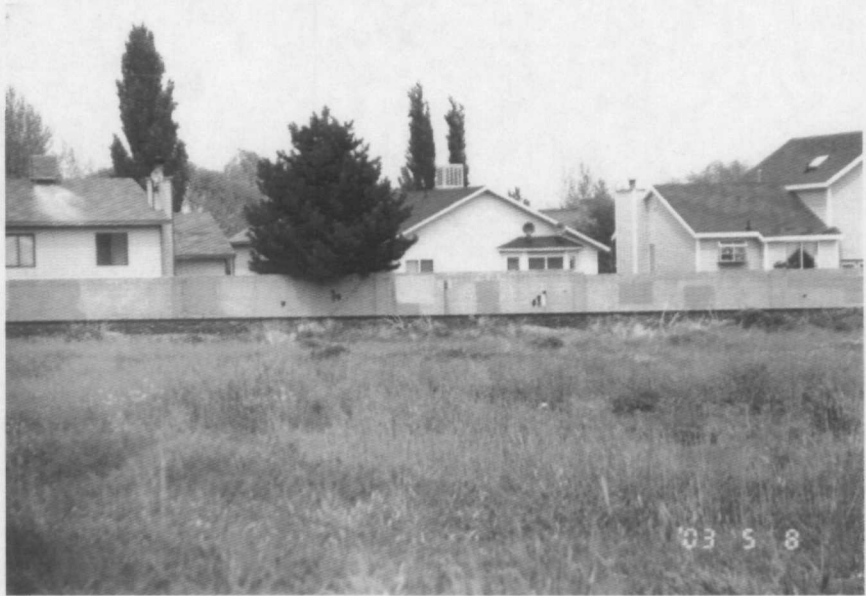
**Figure 4:** The fence line of the next Sugar Creek Condos abuts on the creek channel

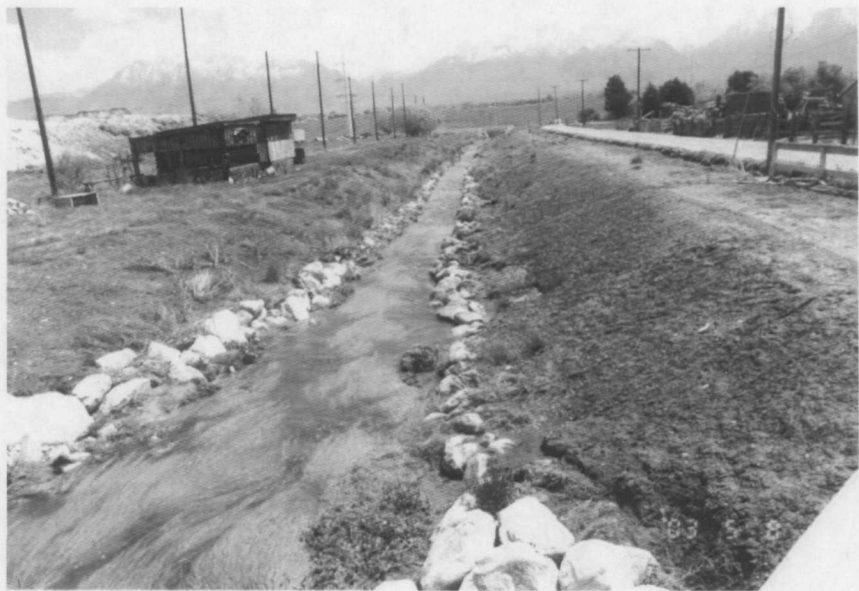
**Figure 5:** New Bingham Creek Channel near the Jordan River

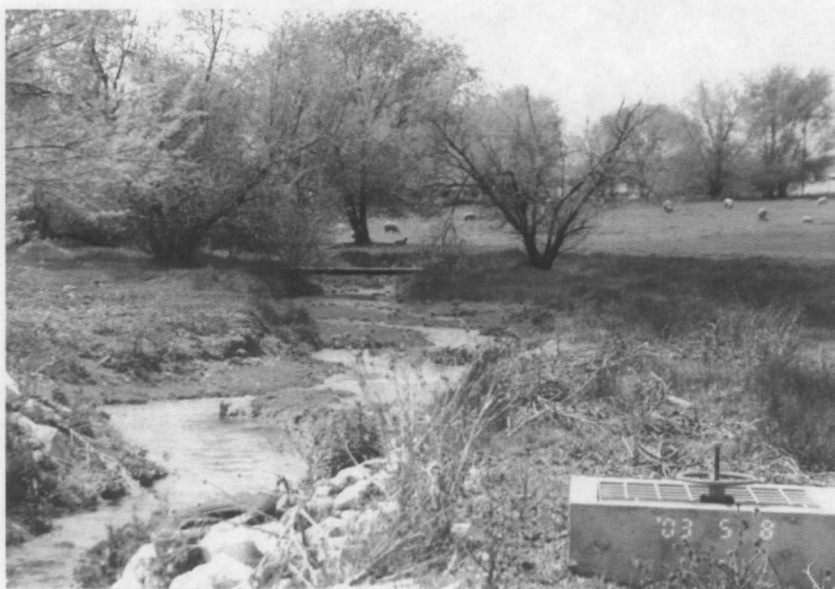
**Figure 6:** Diversion structure between old and new channels

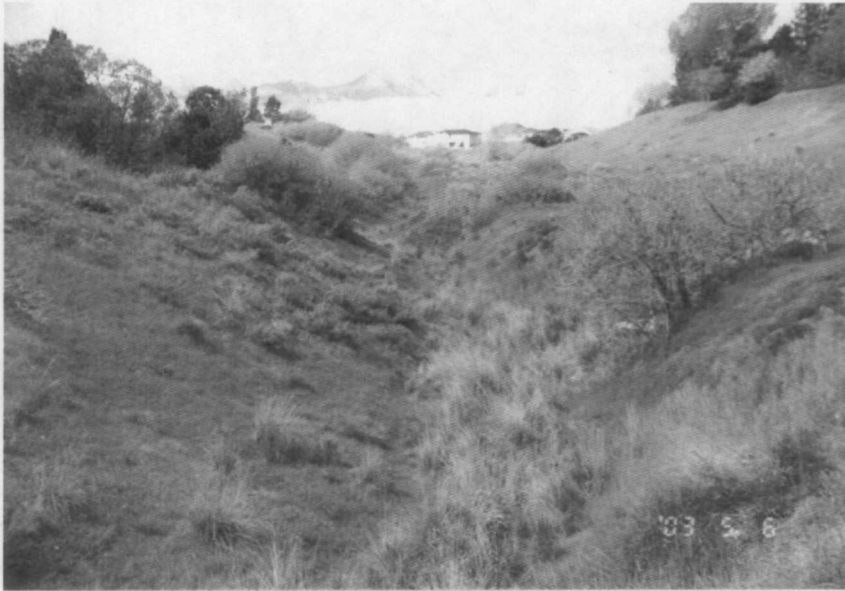
**Figure 8:** Revegetation of Bingham Creek Channel

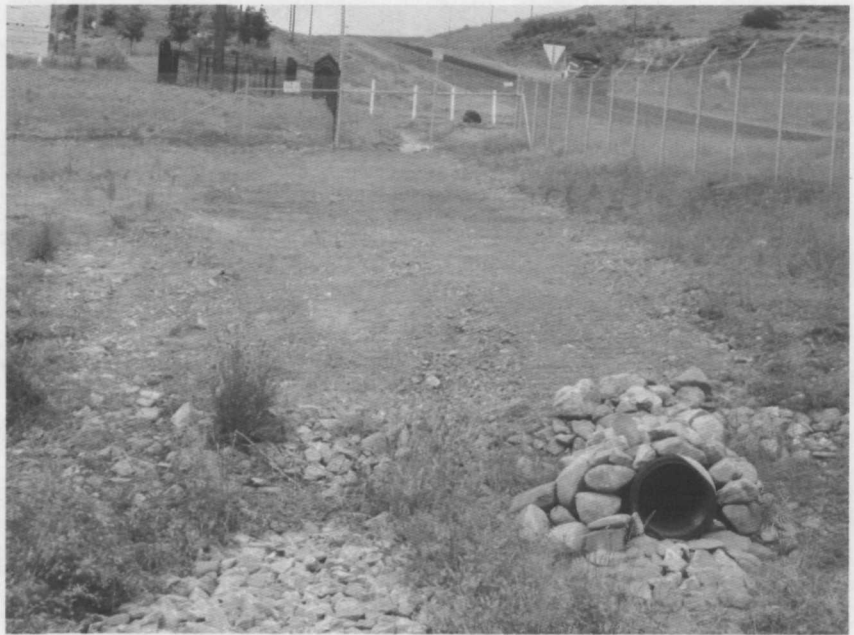
**Figure 11:** Outfall of new pipe directing road runoff to creek

The erosional gully was filled in and the runoff from the roads was directed to a new pipe laid underground ending at the channel along the eastern side of Rt. 111. At the outlet of the pipe, rip rap was added to the creek channel to dissipate the energy at the intersection with the creek. The slope from the inlet of the new pipe to the outfall was sufficient to allow the pipe to be laid in a trench through the capping material only. The cap was thick enough near the roads that the wastes were not encountered during the trenching. The construction was accomplished using rubber tired equipment (as opposed to tracks) to minimize damage to the vegetation along the creek. The project was conducted using labor and construction equipment provided by the Trans Jordan Landfill and pipe provided by the City of South Jordan, with revegetation to be provided by Kennecott this fall. (See attached photos.) Project managers were Dwayne Wooley, General Manager of the Trans Jordan Landfill, and Steve Nobel, City Engineer of South Jordan City. Kennecott was consulted throughout the construction - they are the property owner of the creek channel in that area.

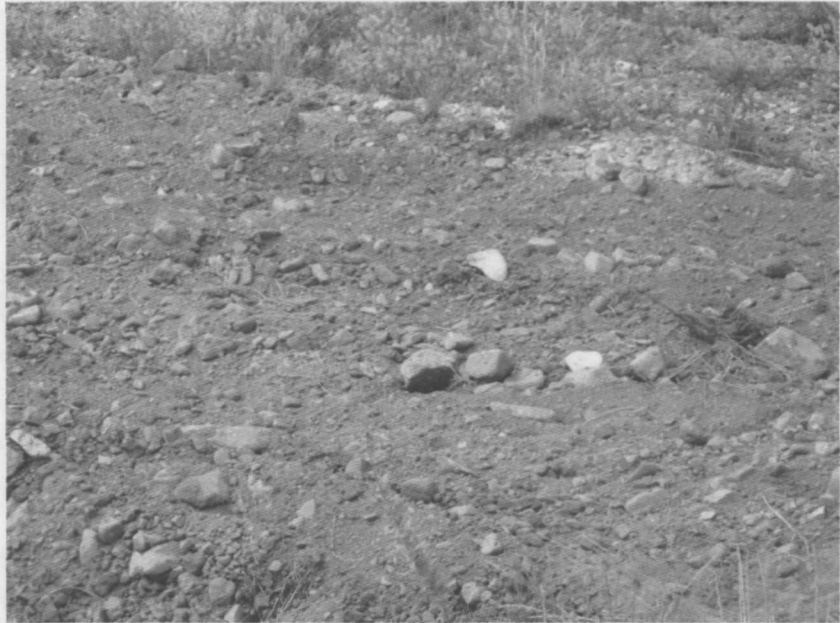
**Figure 12:** The erosion gully is filled in and regraded.

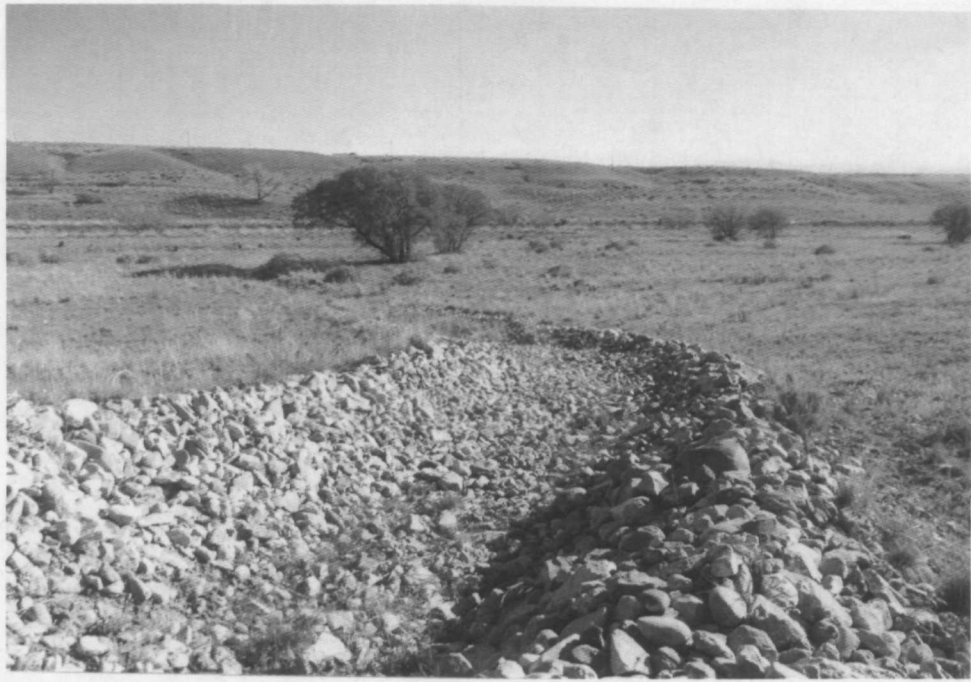
**Figure 15:** Drainage ditch with larger rip-rap lining

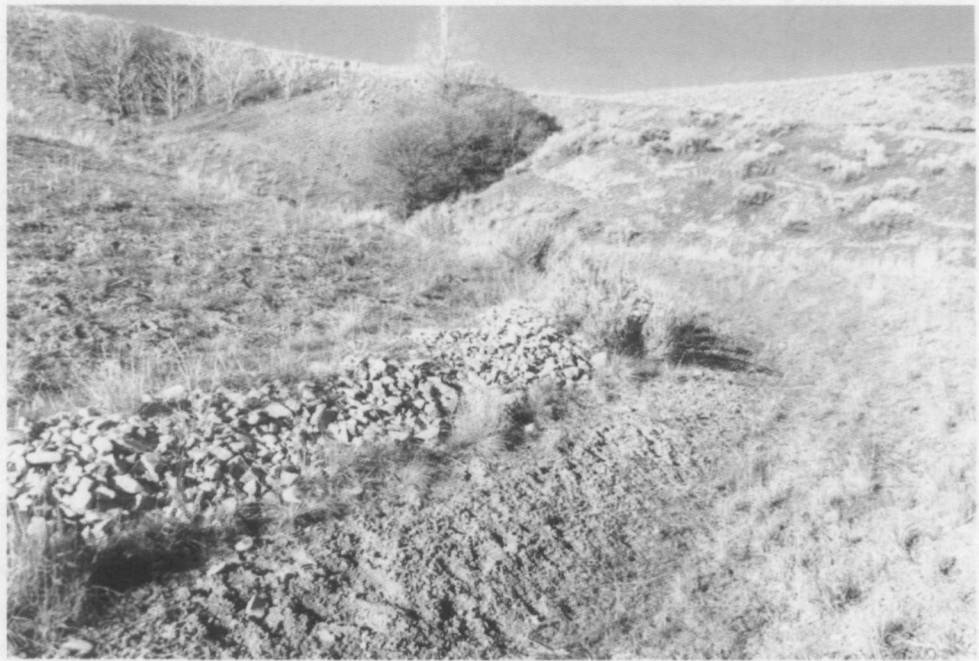
**Figure 14:** Upgradient side of the Copperton Tails cap

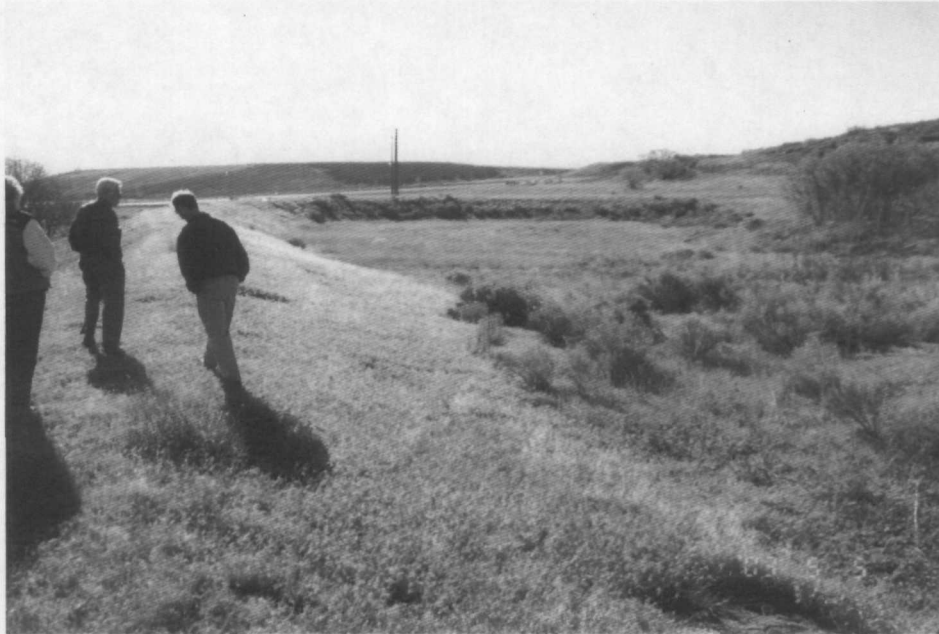
**Figure 16:** Stormwater retention basin dikes and revegetation of area

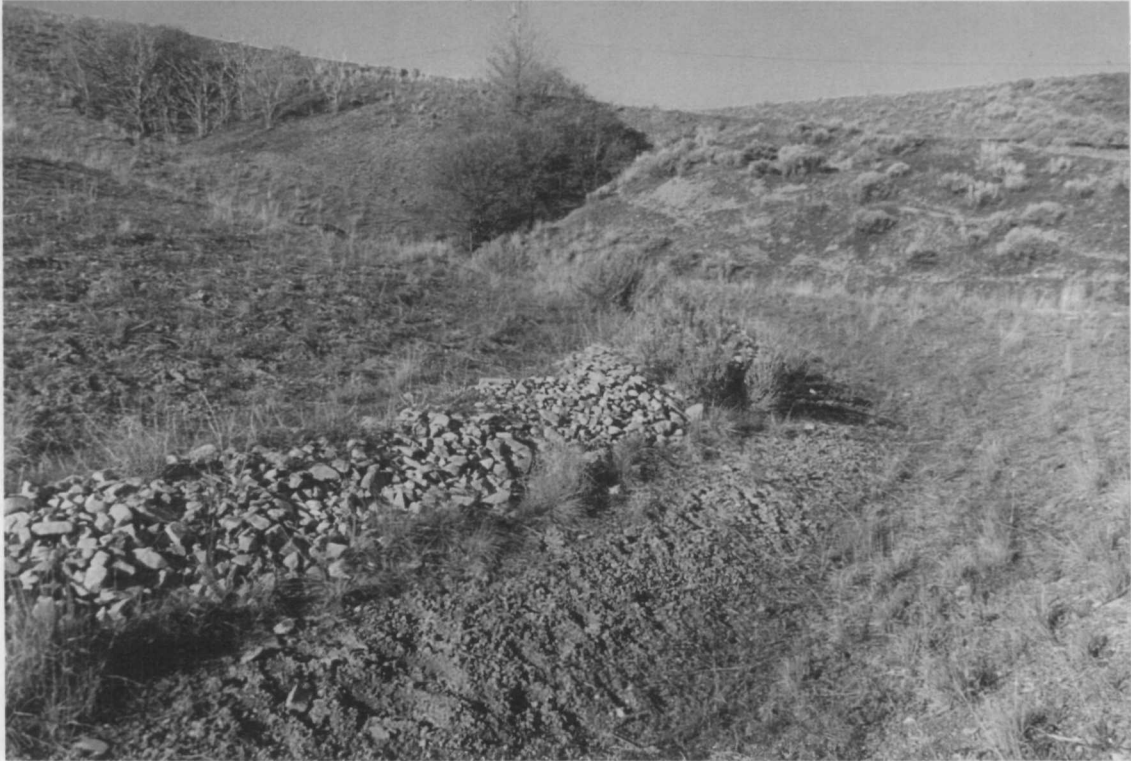
Riprap along edge of cap on western (upstream) side.

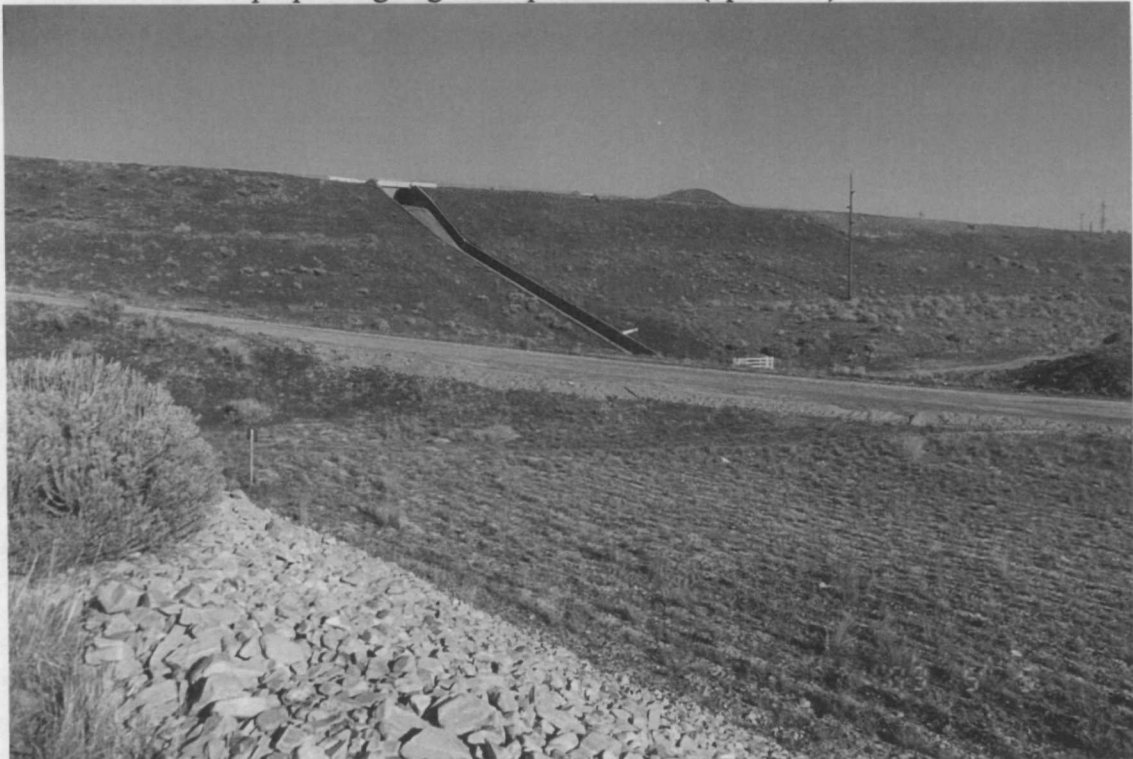
Large Bingham Reservoir Dam from tailings pond showing riprap on the upstream side

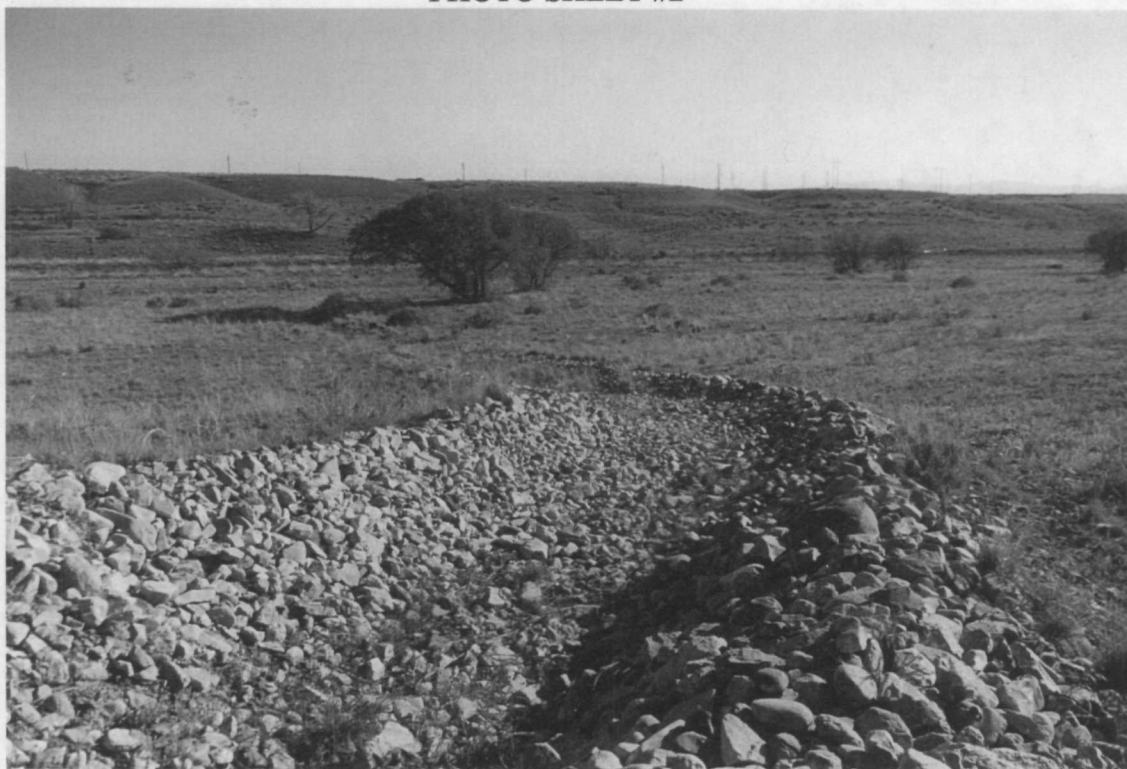
Riprap and drainage ditch from NE corner of cap to retention pond area

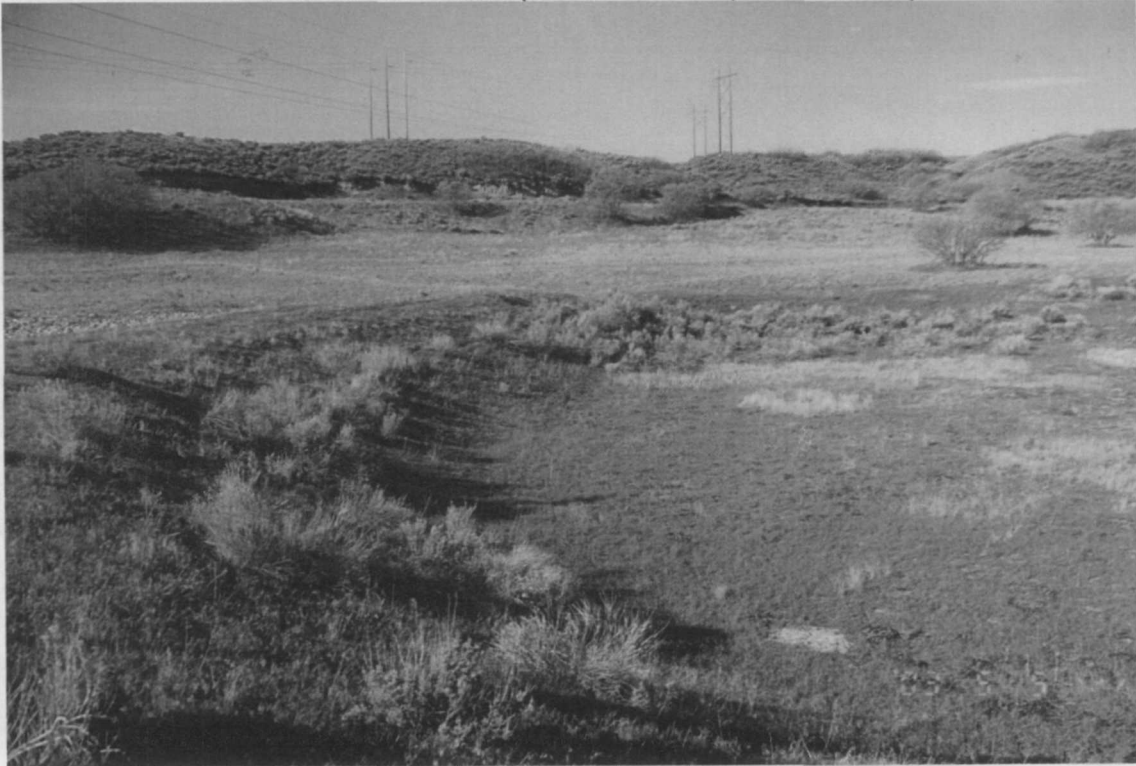
Retention Basin, revegetation with grass, trees

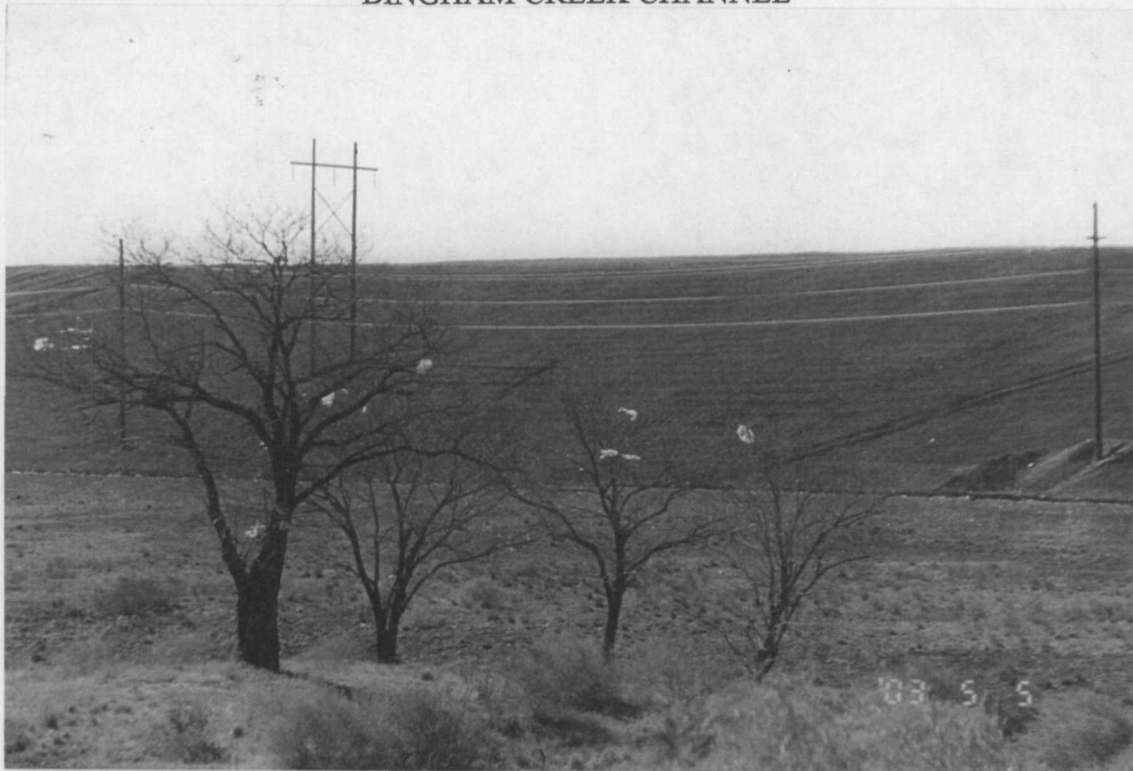
Bingham Creek near Rt.111 showing landfill on south bank and "parachutes" in trees

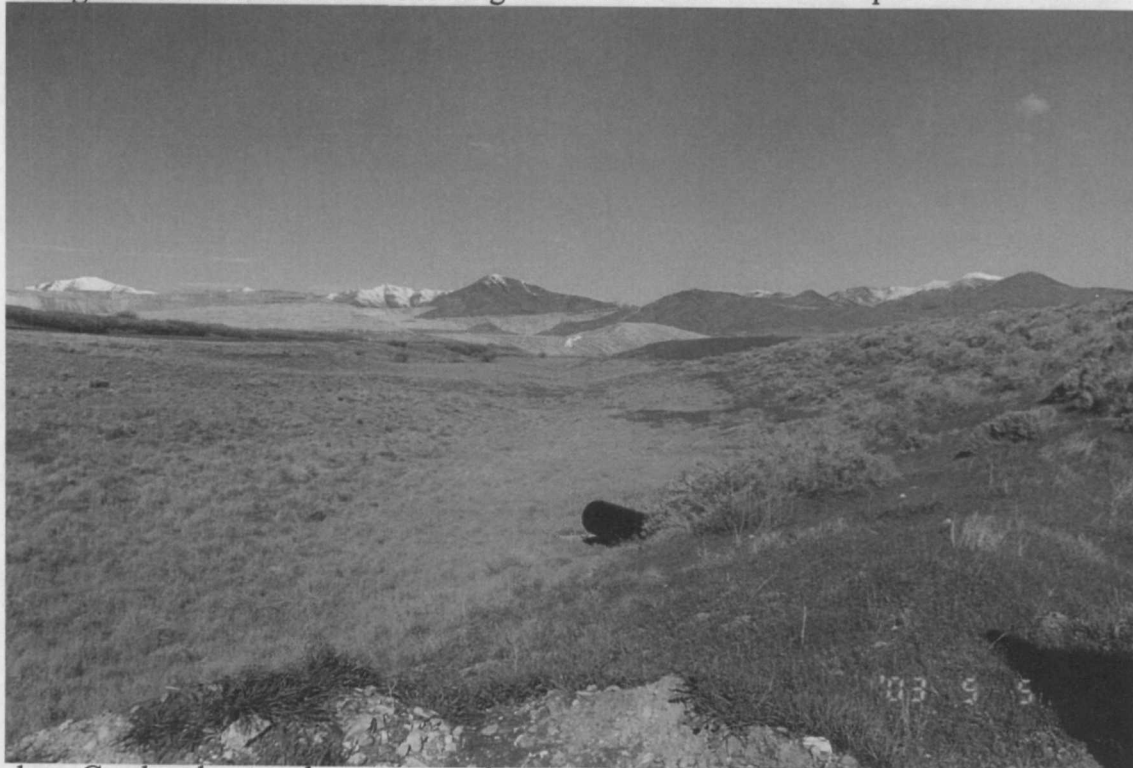
Bingham Creek culvert under access road near power substation at eastern boundary of Zone 19, revegetation

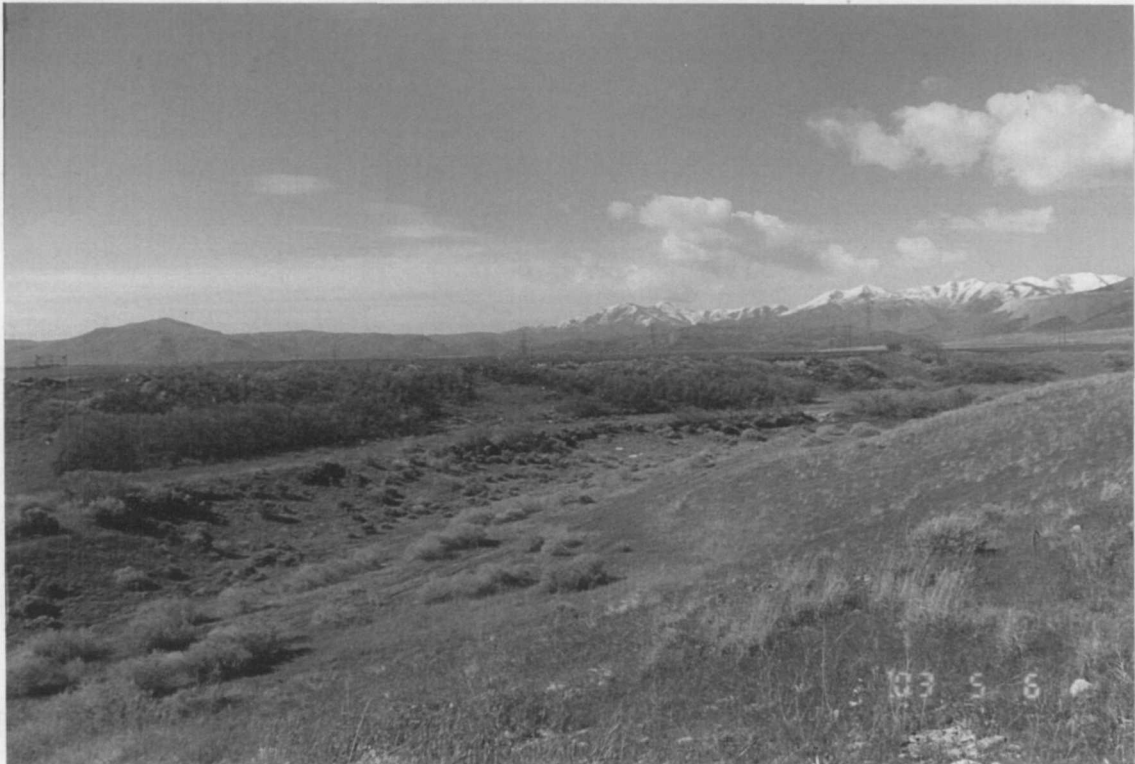
Bingham Creek Channel adjacent to Bingham Flats

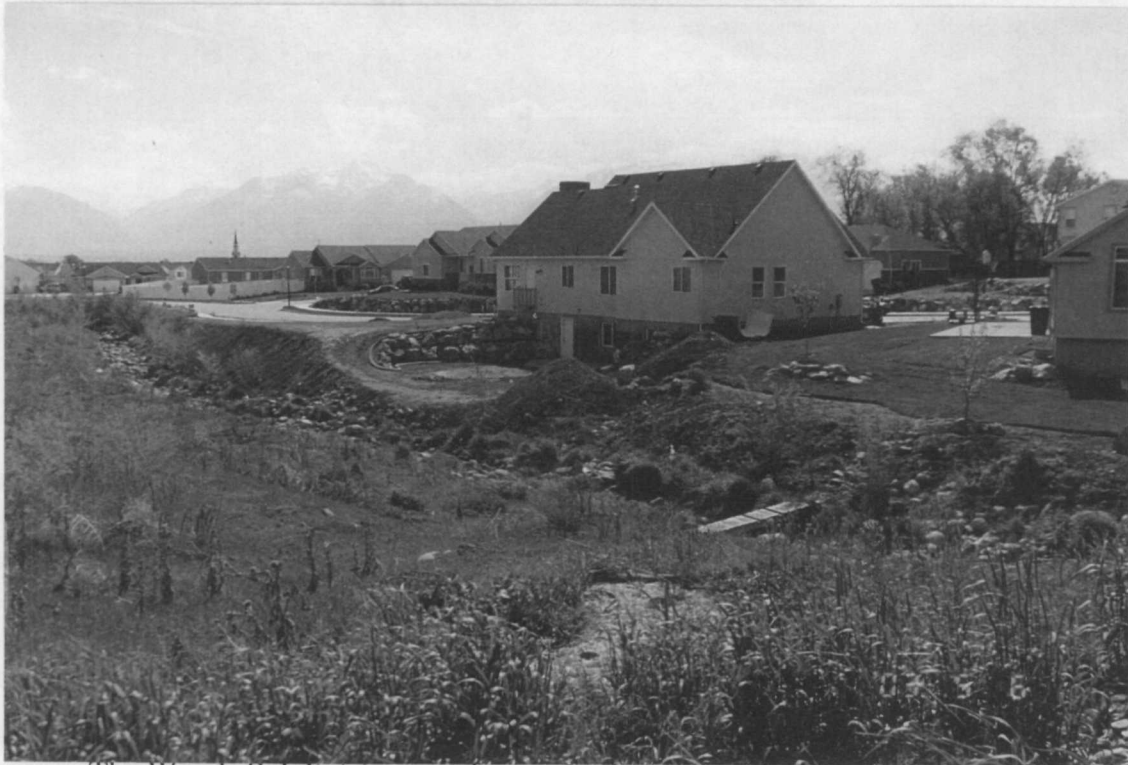
The Woods Subdivision new houses back up to creek channel near hospital

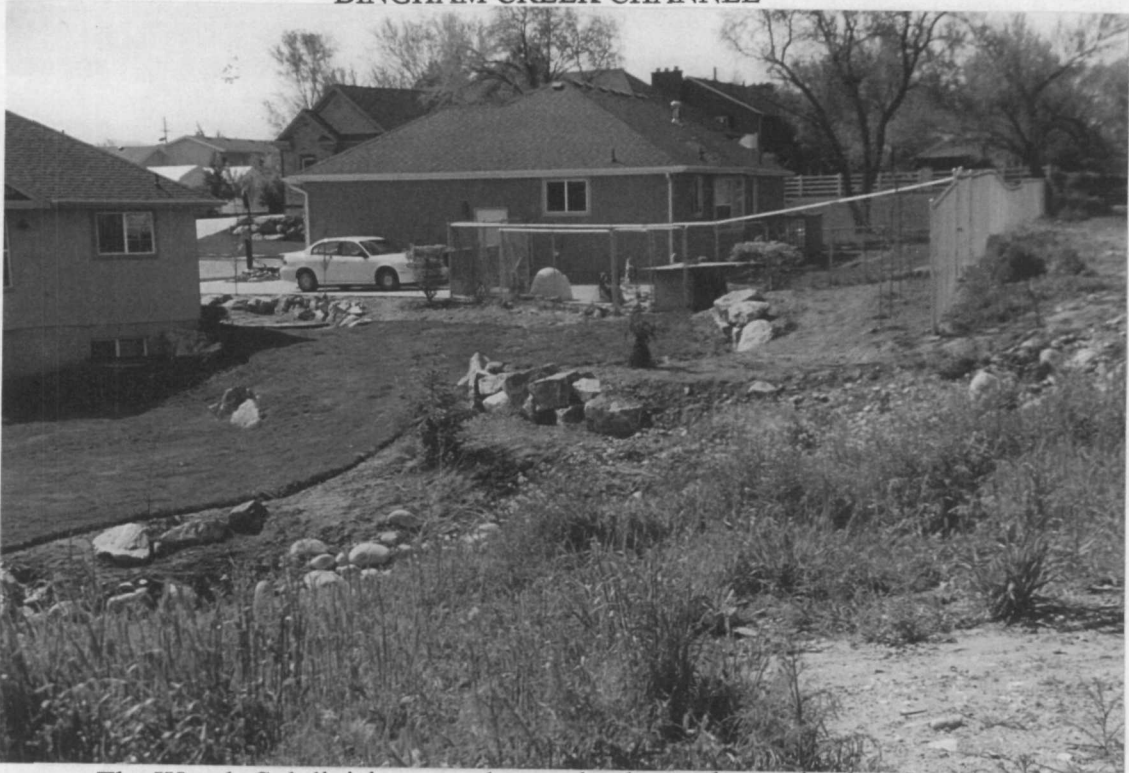
The Woods Subdivision, new homes landscaped up to banks of creek.

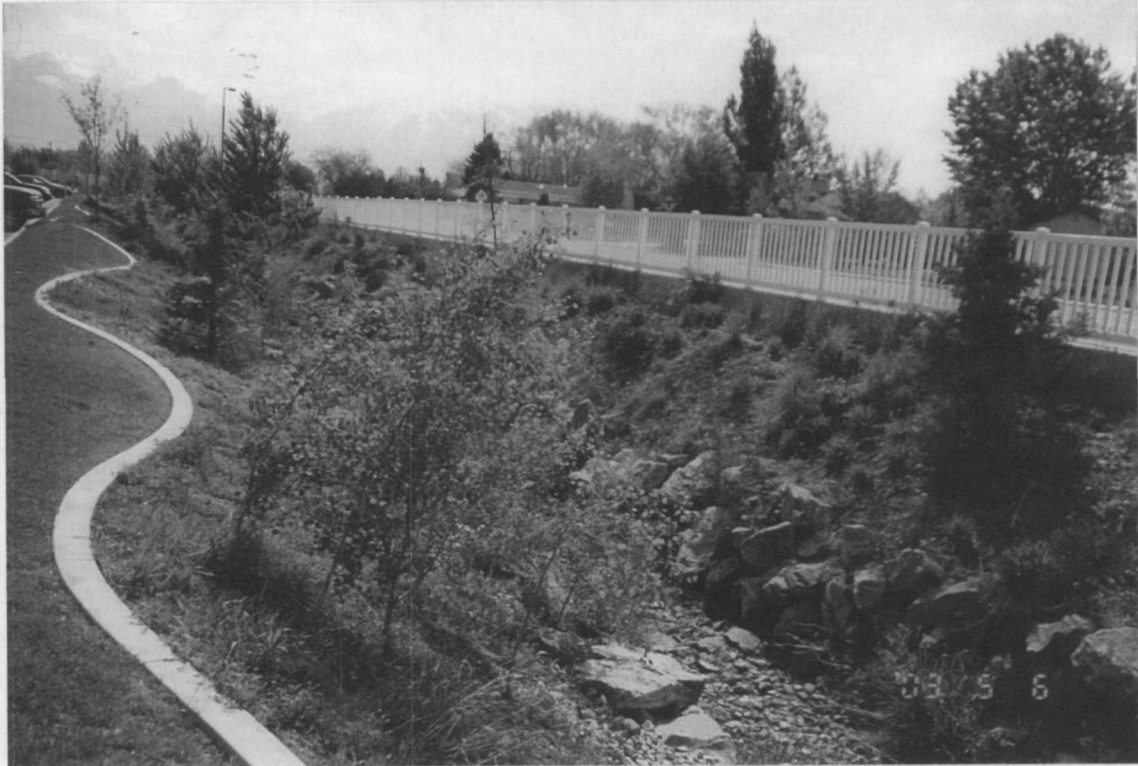
Bingham Creek Channel in front of Cascade Springs Apartments

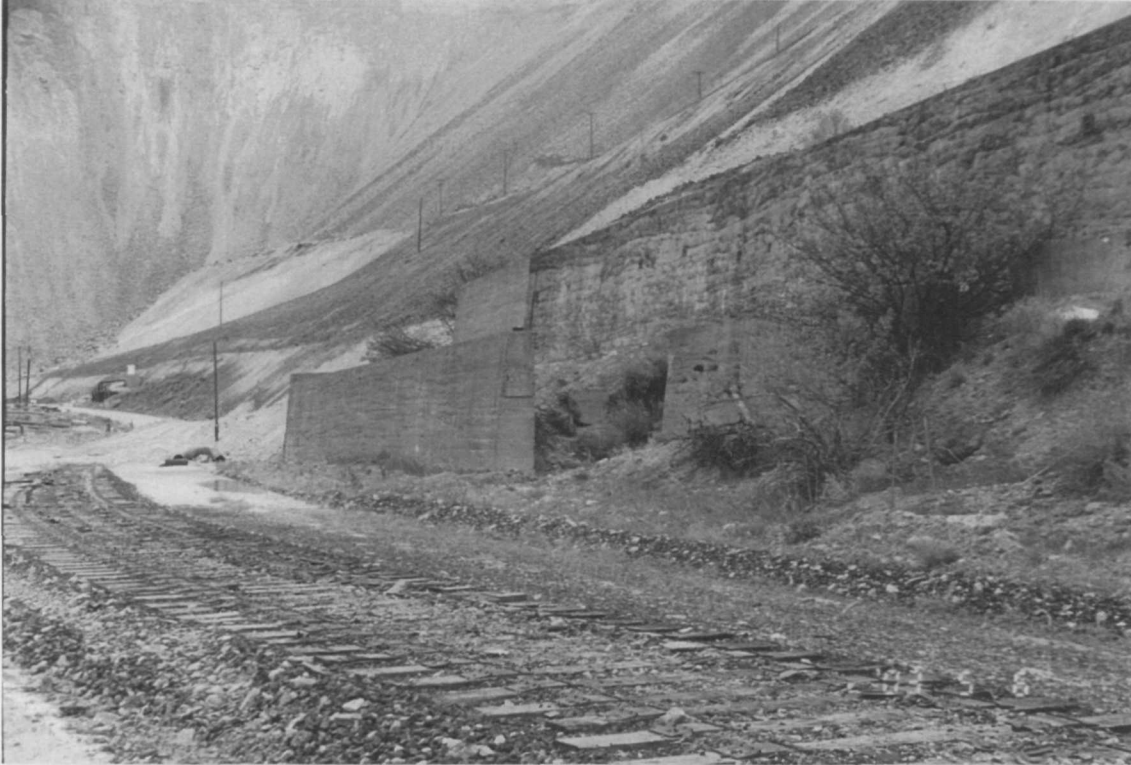
Foundations of the Utah Copper Mill in Bingham Canyon

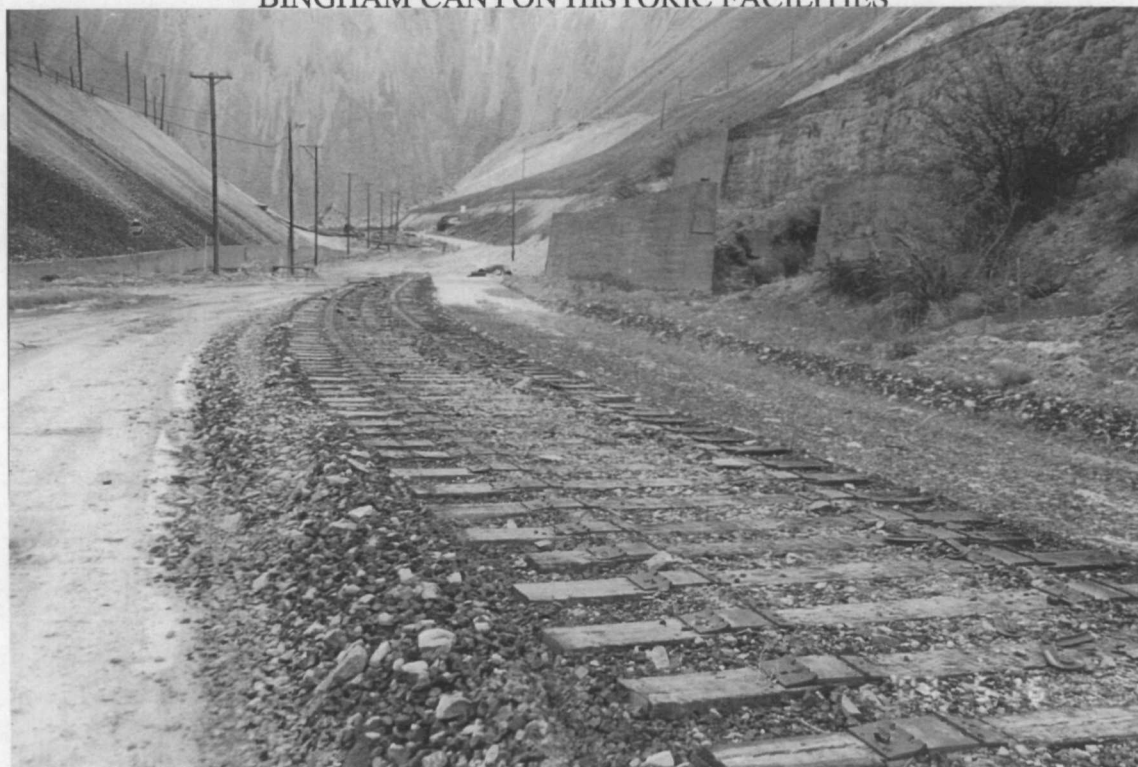
Railroad Tracks being removed from area in front of foundations of Utah Copper Mill

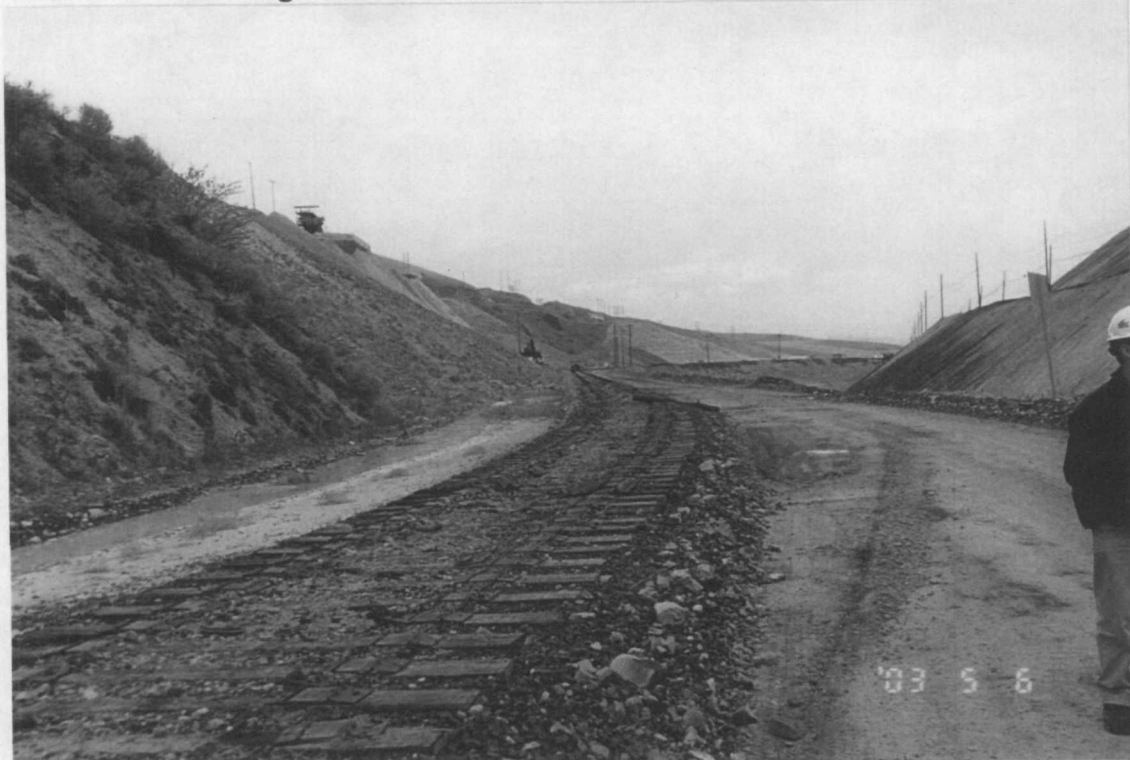
Railroad Tracks being removed, downgradient of Utah Copper Mill site

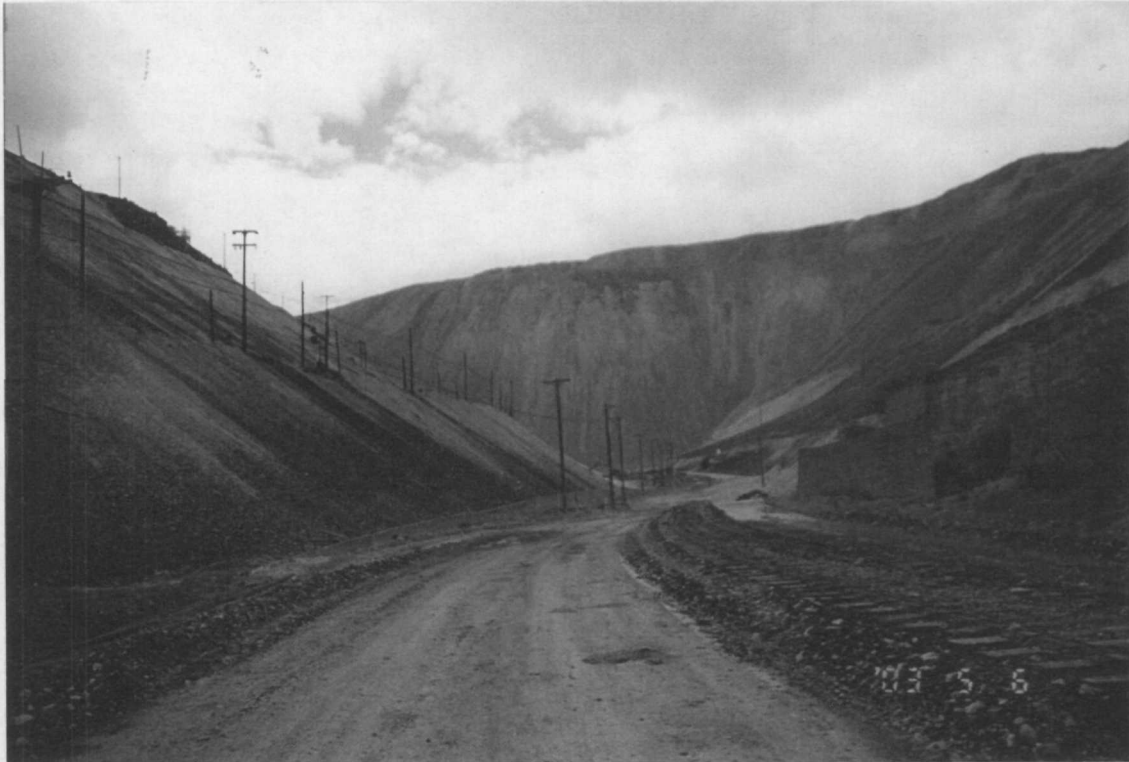
Current toe of the dumps in Bingham Canyon, Utah Copper Mill foundations in foreground

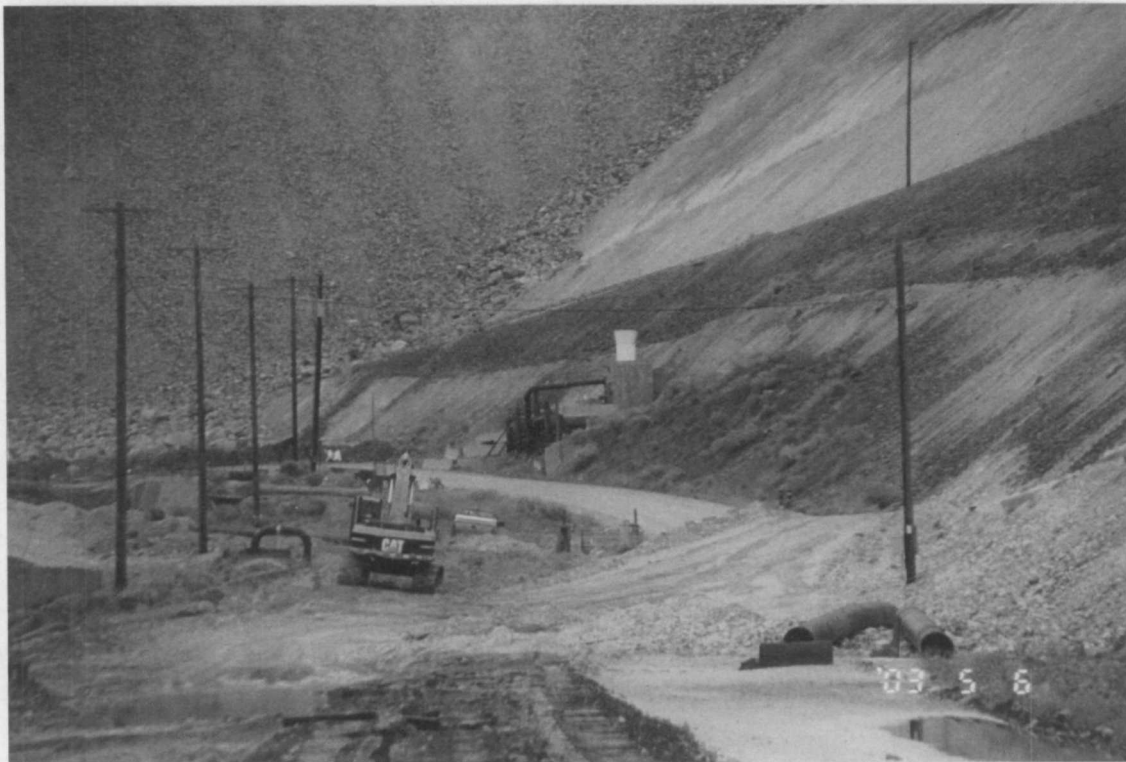
Dry Fork Tunnel and current toe of the dumps

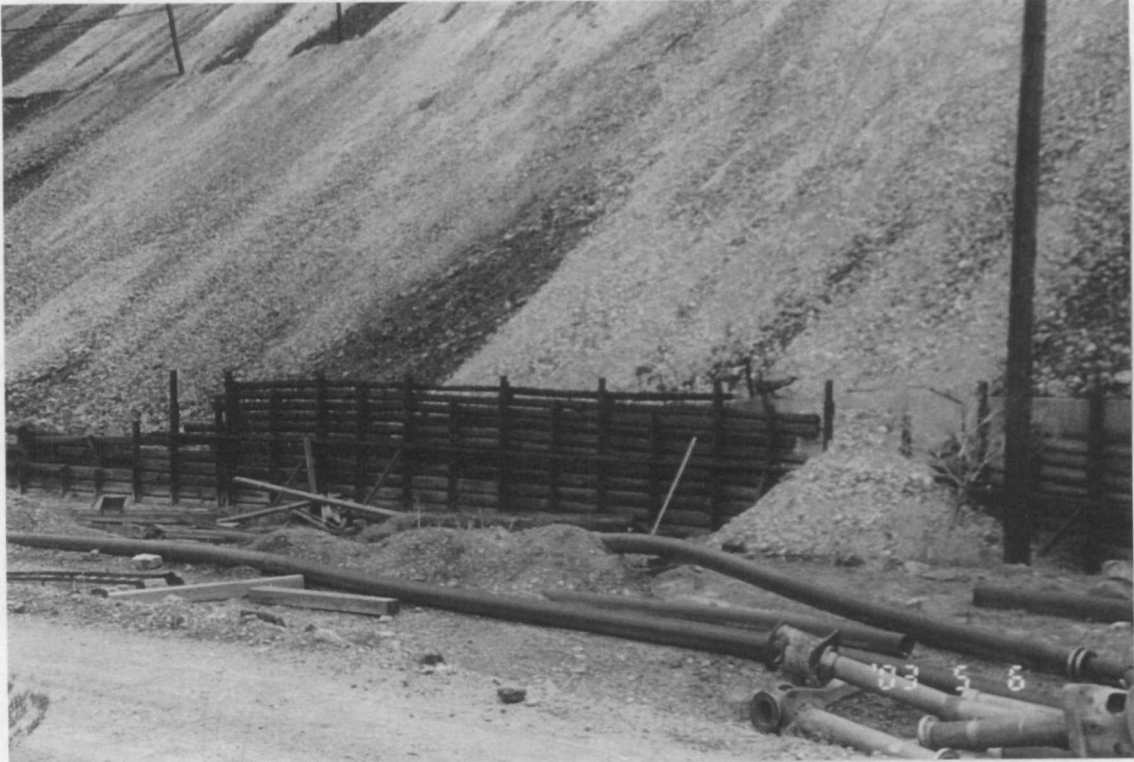
Cribbing along Bingham Creek in the Canyon

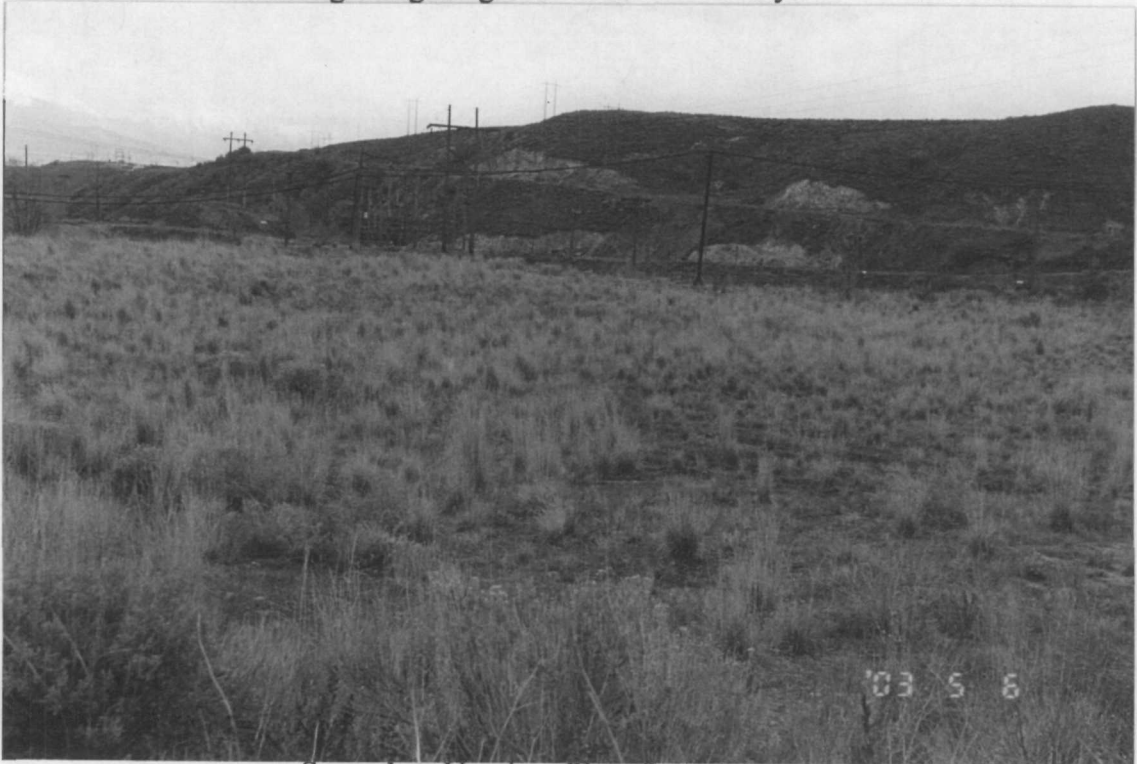
Secondary Uranium Plant footprint

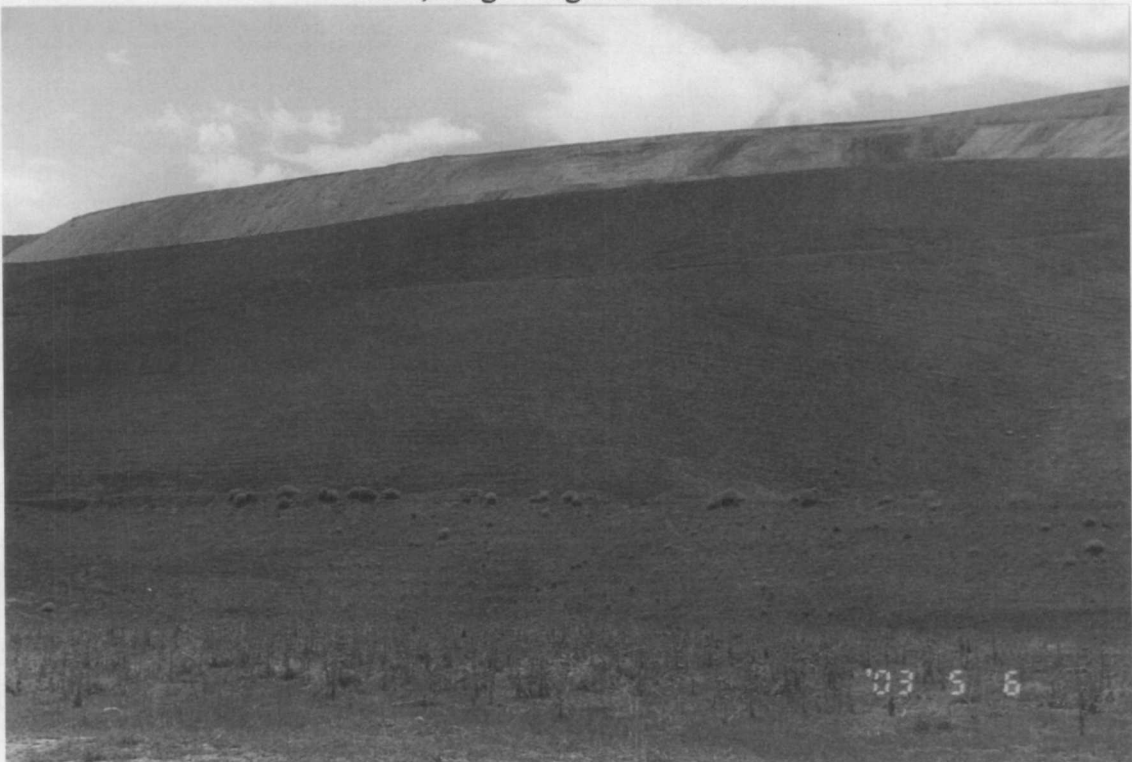
Relaxed Slope of Dumps where sludge, lime, soils mixed and used for the slope
